Home Inspection

Actual Sample Report
123 Main St. North TX ZipCode

PROPERTY INSPECTION REPORT

Concerning: 123 Main St., North, TX ZipCode
(Address or Other Identification of Inspected Property)

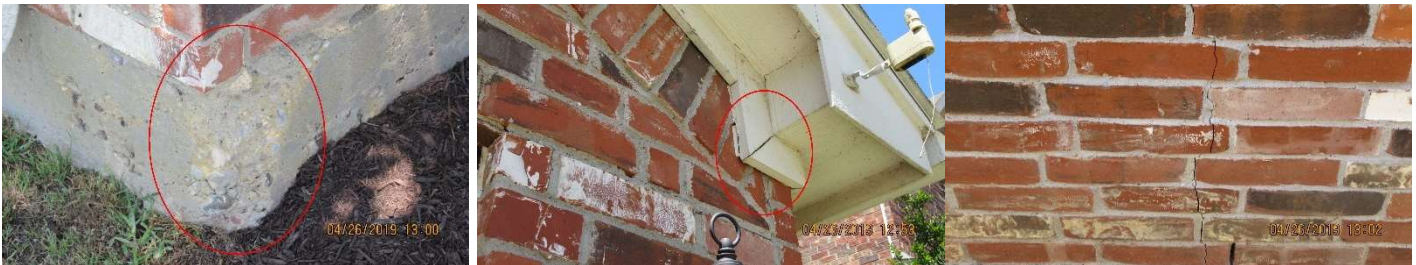
- Corner pop(s) were noted. Corner pops are cracks in the concrete within 3 feet of a corner. These are not considered structural but should be repaired with hydraulic concrete.
- Some frieze board separation. This is an indication of foundation movement. Recommend repairs or monitoring for future movement and or repairs.
- Vertical cracking in exterior brick wall
- Window in northwest bedroom will not open more than 8 inches

- At this time, the foundation appears to be supporting the structure and immediate significant repair needs are not evident.
- Prior to closing, the foundation should be inspected by a qualified structural engineer, familiar with the soils and construction methods of the region, in order to determine if permanent repairs are required.

- At this time, the foundation appears to be supporting the structure and immediate significant repair needs are not evident.
- Corner pop(s) were noted (Corner pops are cracks in the concrete within 3 feet of a corner. These are not considered structural but should be repaired with hydraulic concrete.)
- Some frieze board separation (This is an indication of foundation movement. Recommend repairs or monitoring for future movement and or repairs.)
- Vertical cracking in exterior brick wall
- Window in northwest bedroom will not open more than 8 inches

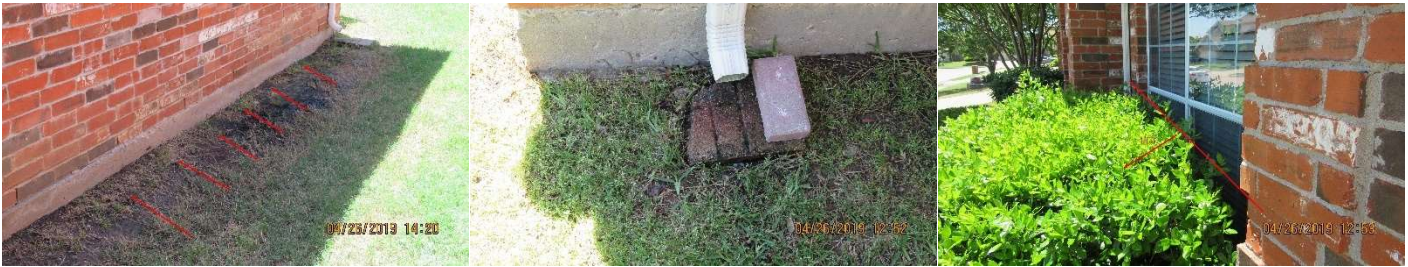
Drainage Condition: Marginal - Current building practices recommend a 6 inch drop within 10 feet to move water away from foundation.

- Negative grade noted at north side of structure.
- All downspouts should be equipped with splash blocks to prevent erosion.
- Shrubs/Trees/Foliage should be trimmed at least 1 foot from structure.

- Negative grade noted at north side of structure (Current building practices recommend a 6 inch drop within 10 feet to move water away from foundation.)
- All downspouts should be equipped with splash blocks to prevent erosion
- Shrubs/Trees/Foliage should be trimmed at least 1 foot from structure

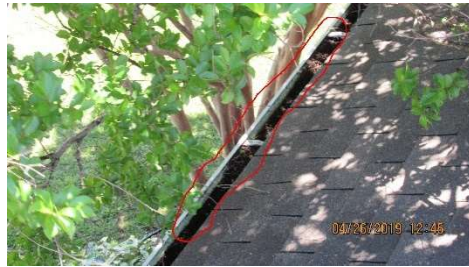
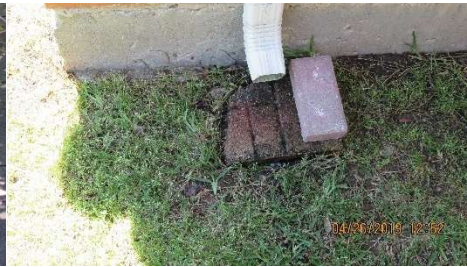
- Gutters: Bent Sections Debris
- Downspouts: Missing Extension/splash block missing

- Extension/splash block missing
- Debris inside of gutters

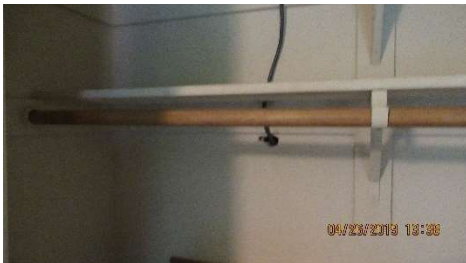
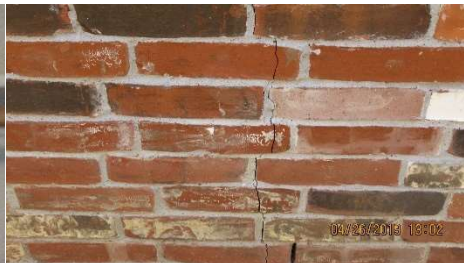
- Hole located in bedroom closet
- Crack visible in brick located on north side of structure

- Crack visible in brick located on north side of structure (This is an indication of foundation movement. Recommend repairs or monitoring for future movement and or repairs.)
- Hole located in bedroom closet

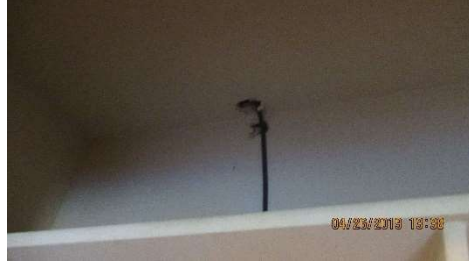
Comments: Hole in ceiling located in bedroom closet

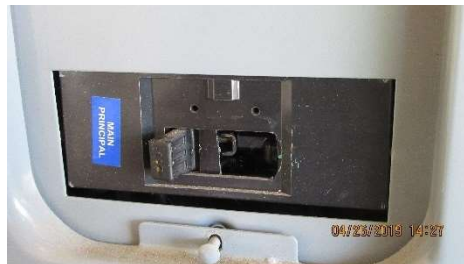
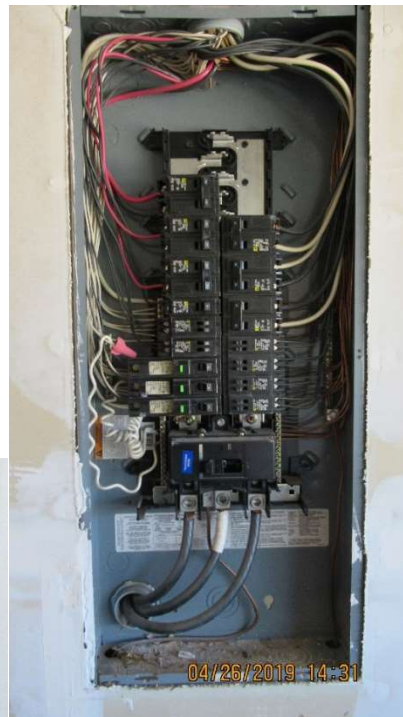
Comments: 200amp main breaker is damaged

- Recommend a License Electrician to repair/replace broken breaker

- 200amp main breaker is damaged
- I recommend a License Electrician to evaluate and repair as required.

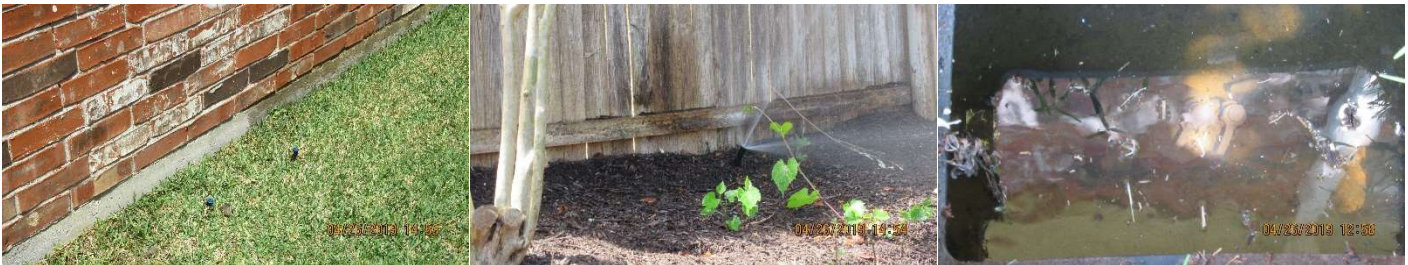
- Multiple sprinkler heads damaged throughout yard
- Zones not labeled in control box
- Check valve located in box full of water

Additional Notes: Recommend irrigation company to service unit before use.

- Multiple sprinkler heads damaged throughout yard
- Zones not labeled in control box
- Check valve located in box full of water
- I recommend a Certified Sprinkler Company evaluate and repair as required.
